Denis Creedon, B.E., MIEI.

CONSULTING ENGINEER

PROPERTY INSPECTION REPORT

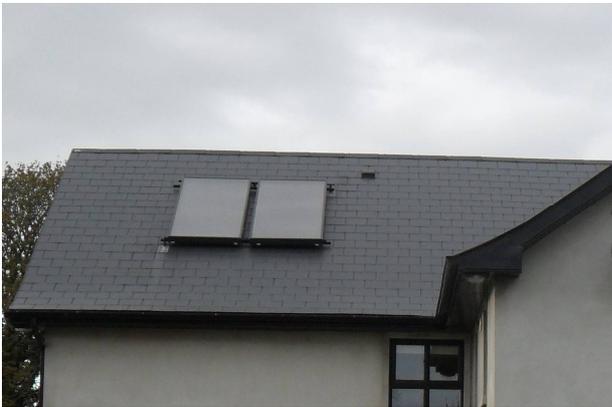
Condition: Slates - Good
Felt - Good
Roof Timbers - Good
Ventilation - Good
Insulation - Good
Gutters - Good, all present and securely fixed in place.
Down pipes - Good, all present and discharge to gutters at footpath level.

External roof surface with vent slate present.

Defects: None observed.

Action required: Regular maintenance including inspections for damaged or missing slates which should be replaced. Gutters should be cleaned out each year to remove leaves and moss. Any build up of moss on the slates should be removed regularly. No alterations should be carried out to the roof timbers without engineering supervision.

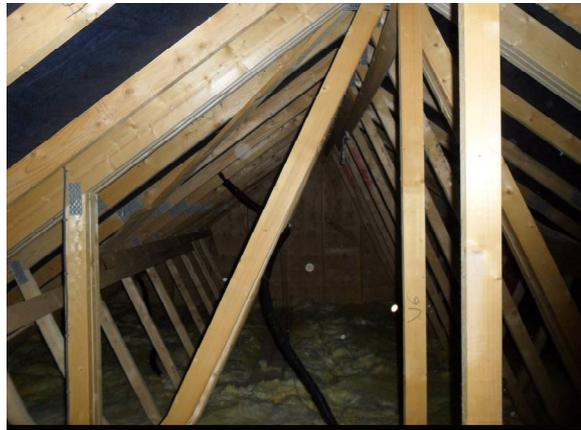
Internal trusses with wind bracing.

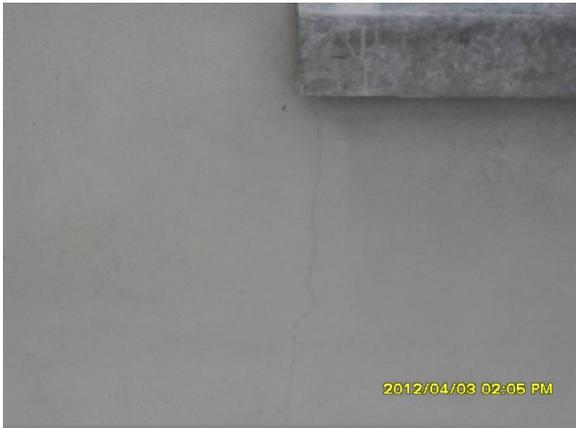
Hairline plaster crack under window

Defects: Some minor hairline cracking externally around openings and drying shrinkage cracks internally at the intersection of walls and ceilings.

Action required: Painting and sealing minor cracks externally, sealing minor cracks internally. No alterations should be carried out to the walls without engineering supervision.

Cost of repairs: €600 estimated.

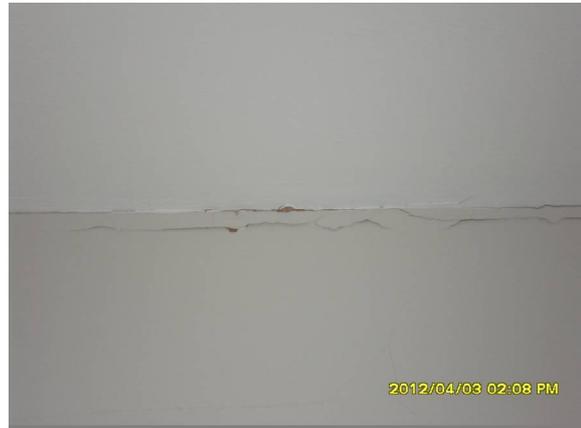
Cracking at intersection of wall and ceiling

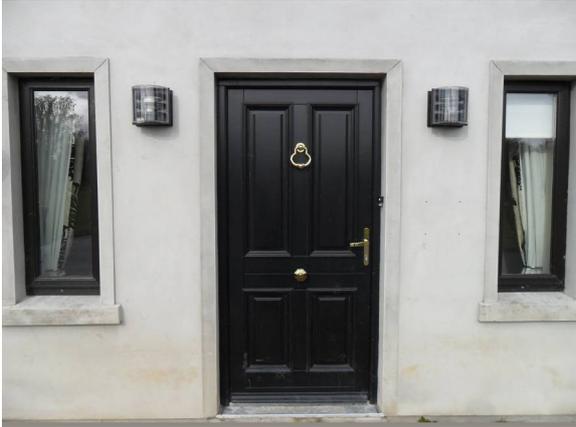
All doors and windows are in good working order.

Solid Timber Front door

Defects: None noted.

Action required: Regular maintenance including greasing of hinges.

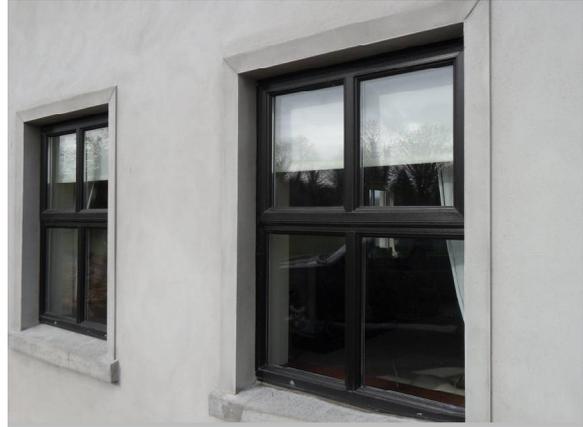
Black PVC double glazed windows

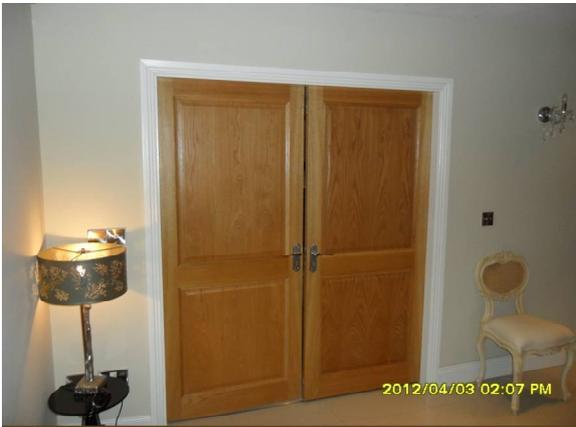
Solid oak internal doors.

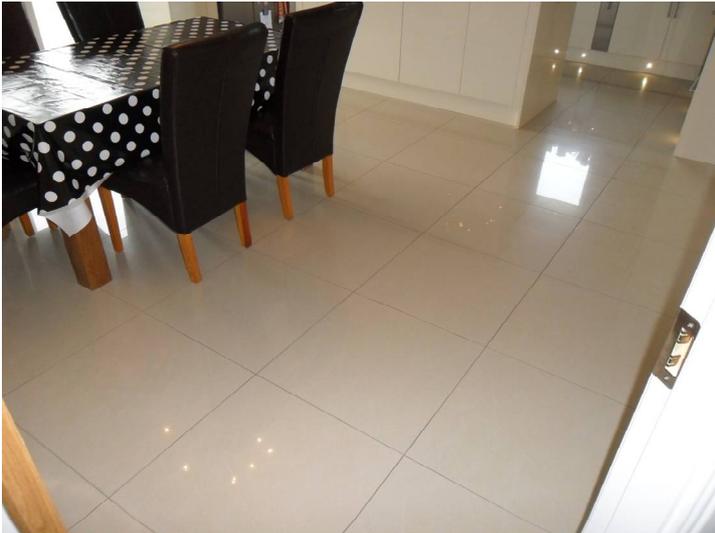
Ground floor construction is in solid construction being power floated concrete slab. There is under floor heating present on the ground floor. The floor finish is carpet and tiles on the ground floor. There is no noticeable deflection or other defects with the ground floors.

Tiled floor in kitchen/dining room.

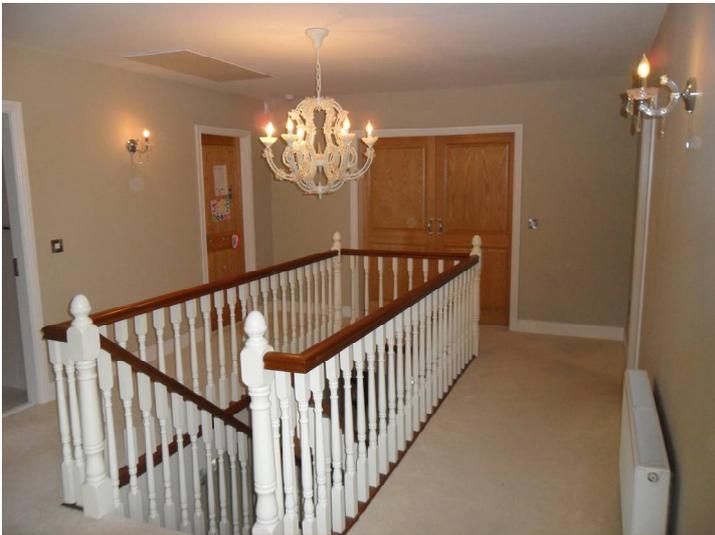
There was no noticeable deflection noted with the upper floors.

Carpet floor finish at first floor level.

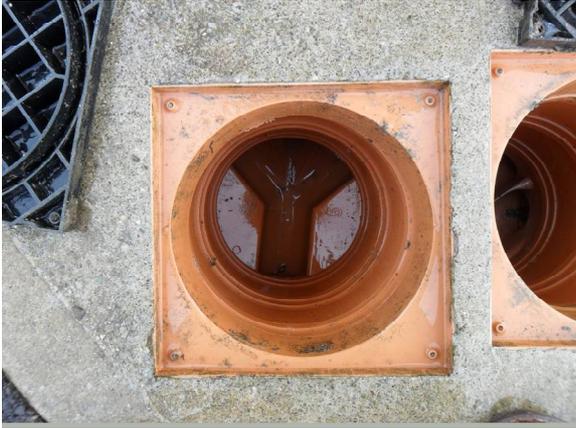
An inspection of the A.J.'s serving the foul and surface water sewers showed that water appears to be escaping adequately.

Foul sewer manhole.

Defects: None noted.

Action required: Regular maintenance. The septic tank should be emptied about every 12 months depending on use by a suitably licensed agent. Regular inspections should be carried out on the percolation area to ensure no ponding water or over saturation is present.

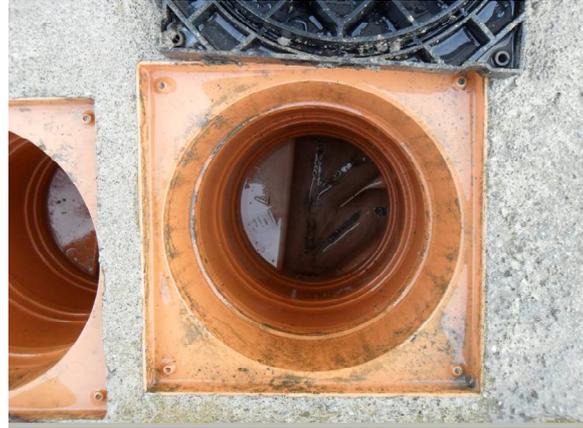
Storm sewer manhole.

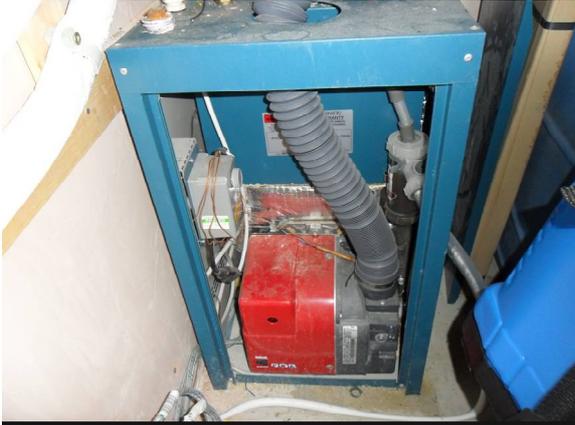
Condensing oil boiler.

Defects: None noted.

Action required: Regular maintenance is required on all oil fired boilers and a qualified plumber should be appointed to carry out annual servicing of the system.

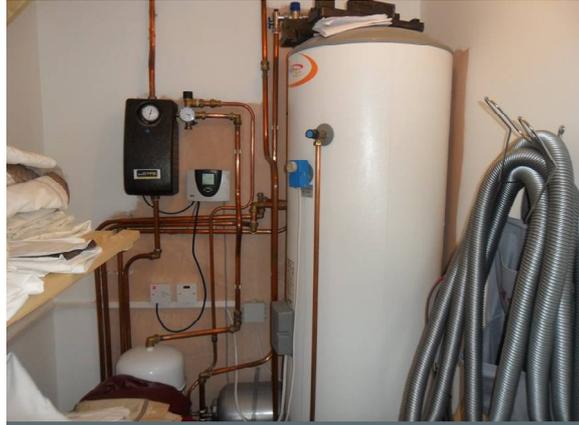
Hot water storage tank in hot press.

The solar panels require annual servicing and addition of anti freeze. This should be done in tandem with the boiler servicing.

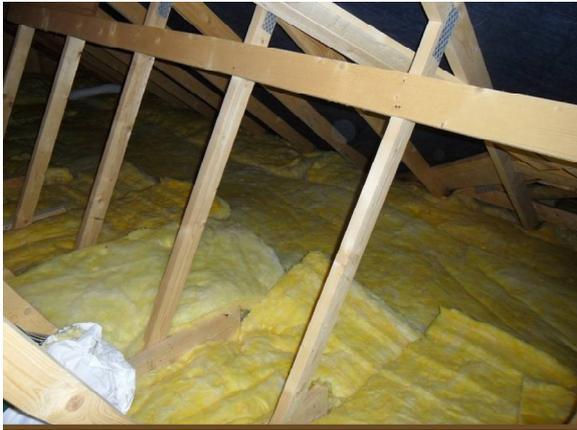
The attic is fitted with 100mm rock wool insulation between the ceiling joists and 200mm rock wool insulation over the joist.

The level of insulation present is compliant with the requirements of the applicable building regulations and provides a very high level of insulation to the dwelling house.

Insulation present in attic.
